Re: Project Notification Form – Phase II Demolitions – Uniroyal Complex, 154 Grove Street  
and Facemate Complex, 5 West Main Street, Chicopee, MA

**PROJECT NOTIFICATION FORM**

Project Name Uniroyal/Facemate Complex – Phase II Demolitions  
Location / Address 154 Grove Street (Uniroyal) and 5 West Main Street (Facemate)  
City / Town Chicopee Falls, MA 01020  
Project Proponent  
Name Thomas Haberlin, Economic Development Director, Office of Community Development  
Address 17 Springfield Street  
City / Town Chicopee, MA 01013  
Telephone # (413) 519-7167

Uniroyal/ Facemate Complex  
Phase II Demolitions  
Chicopee, MA

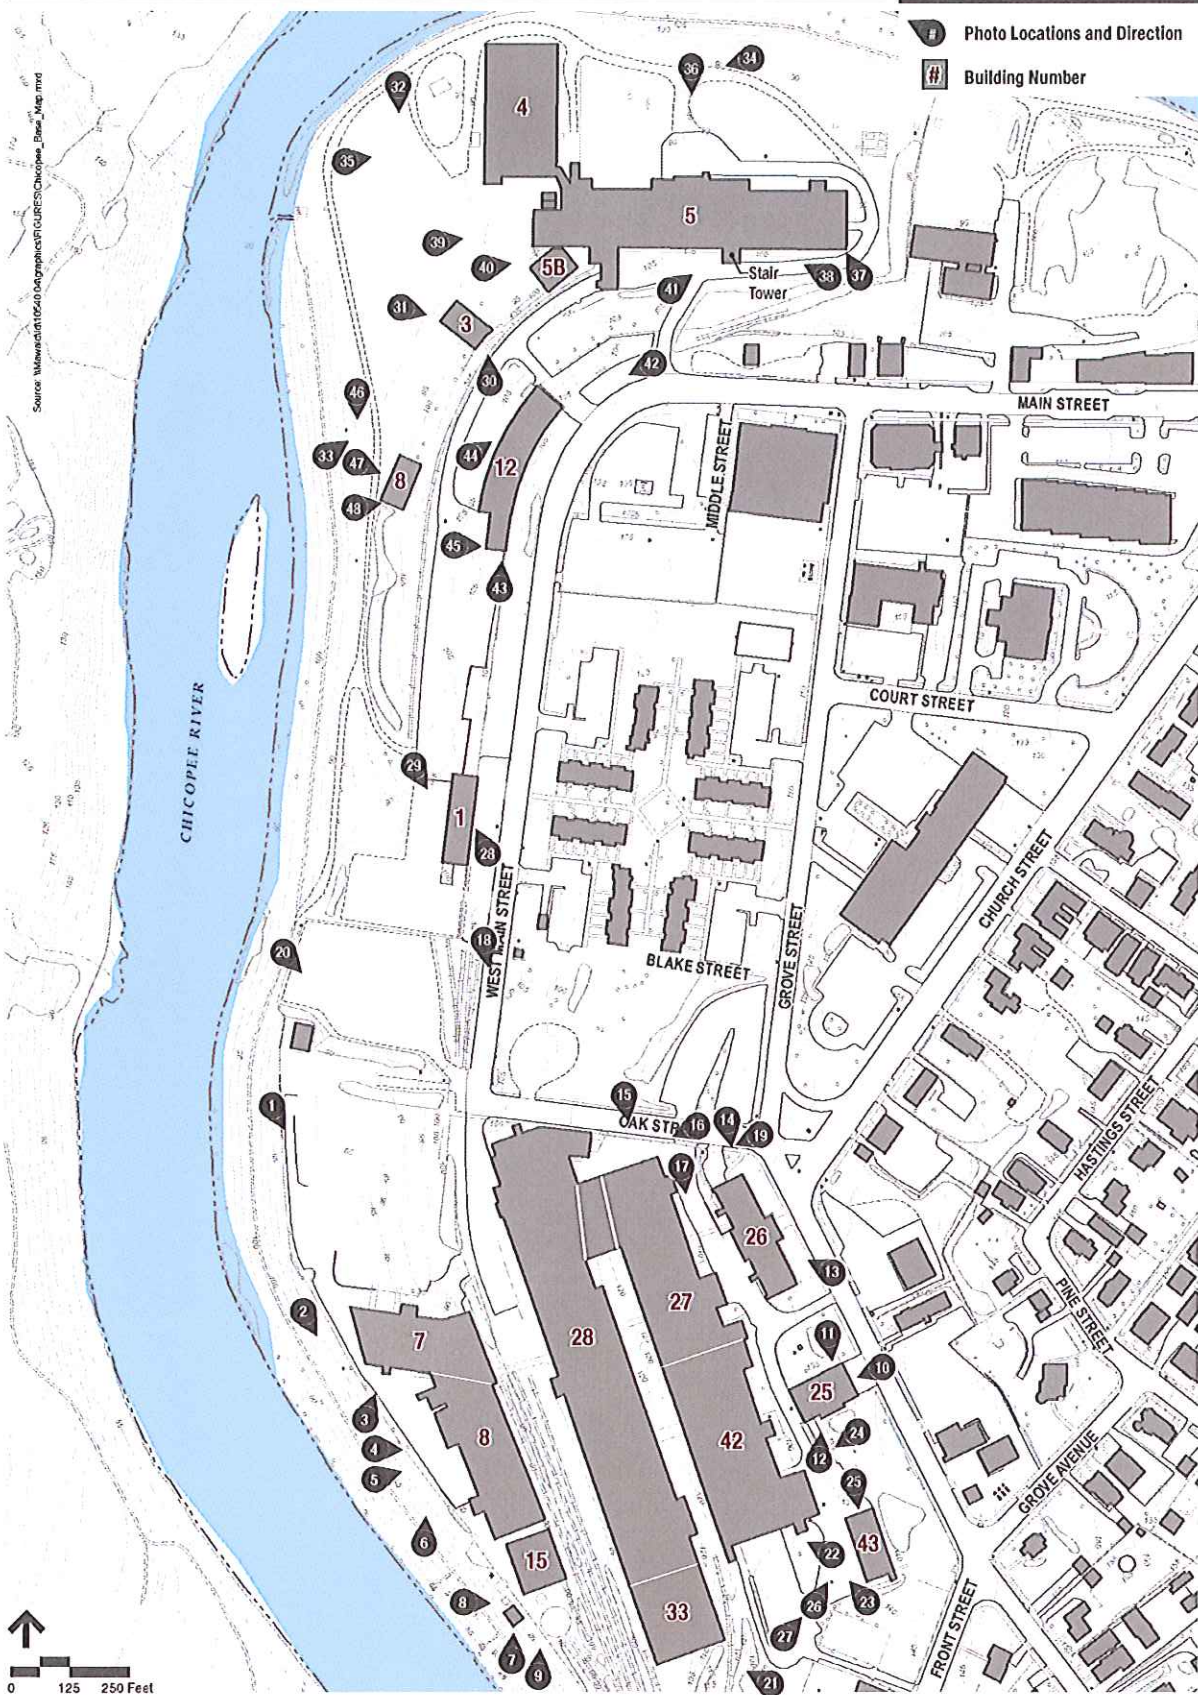
Figure 2

Uniroyal/Facemate Complex  
Phase II Demolitions  
Chicopee, MA  
Photograph Locations

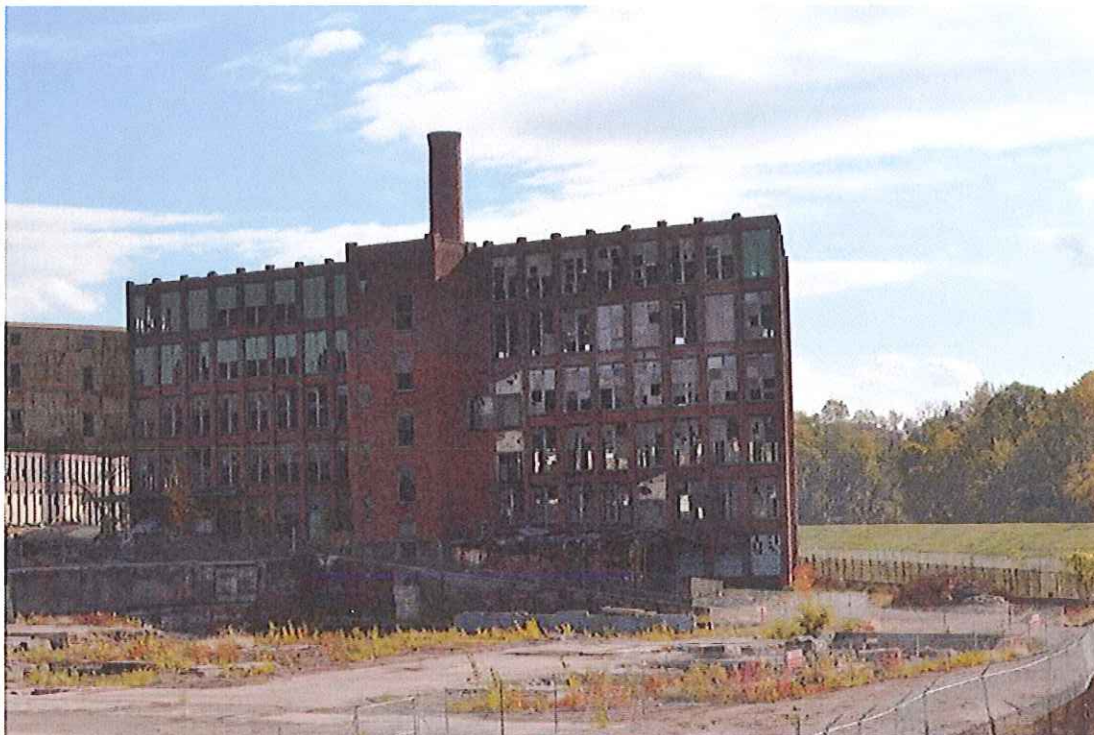
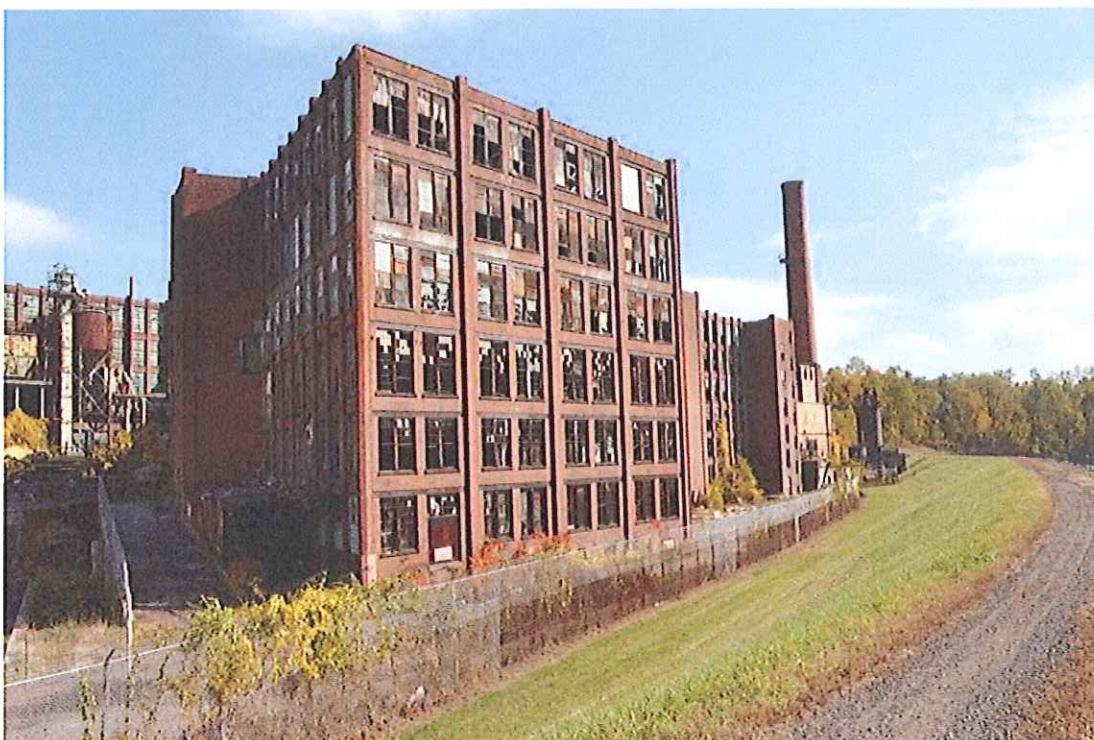
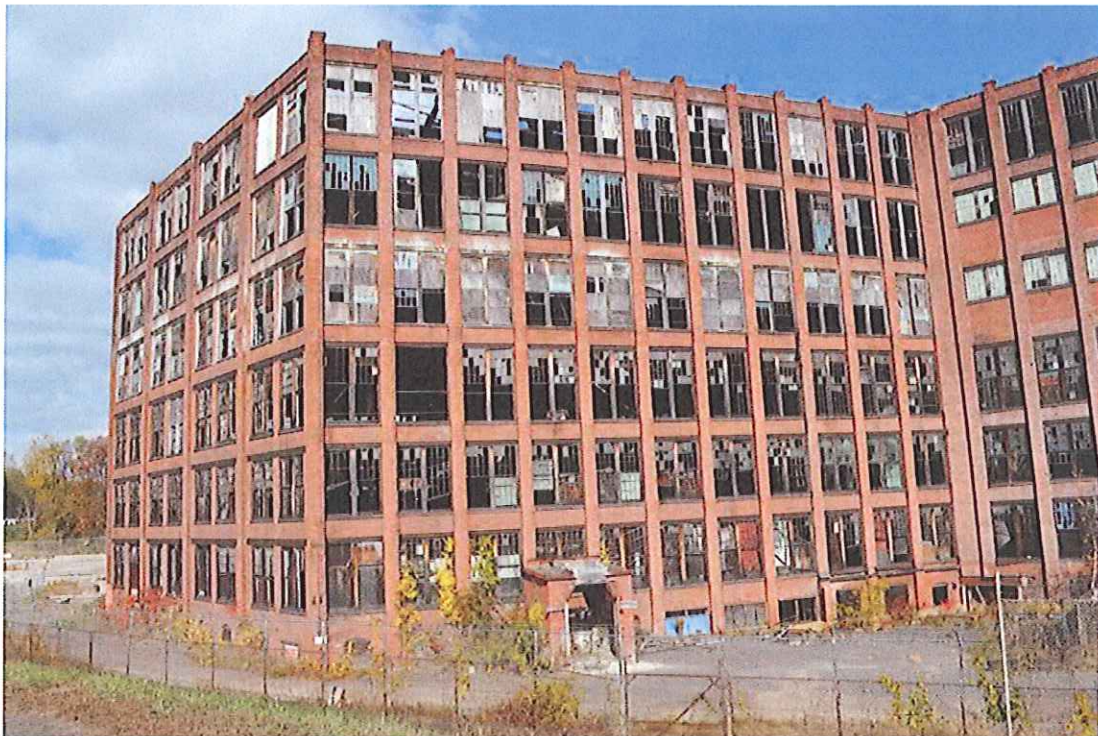
**Building #7** (Photograph #s 1, 2, 3 and 6) is a 6-story (and raised basement) brick pier and spandrel, flat-roofed industrial building with a slightly skewed rectangular footprint. The large paired window openings within each main bay contain original, although very deteriorated, wood multiple-pane sash.

**1. Building #7, Uniroyal Complex, 154 Grove Street, Chicopee, MA. View of north elevation, Photographer facing S, October 2010**

**2. Building #7, Uniroyal Complex, 154 Grove Street, Chicopee, MA. View of west elevation, Photographer facing SE, October 2010**

**3. Building #7, Uniroyal Complex, 154 Grove Street, Chicopee, MA.** View of south elevation, Photographer facing NE, October 2010

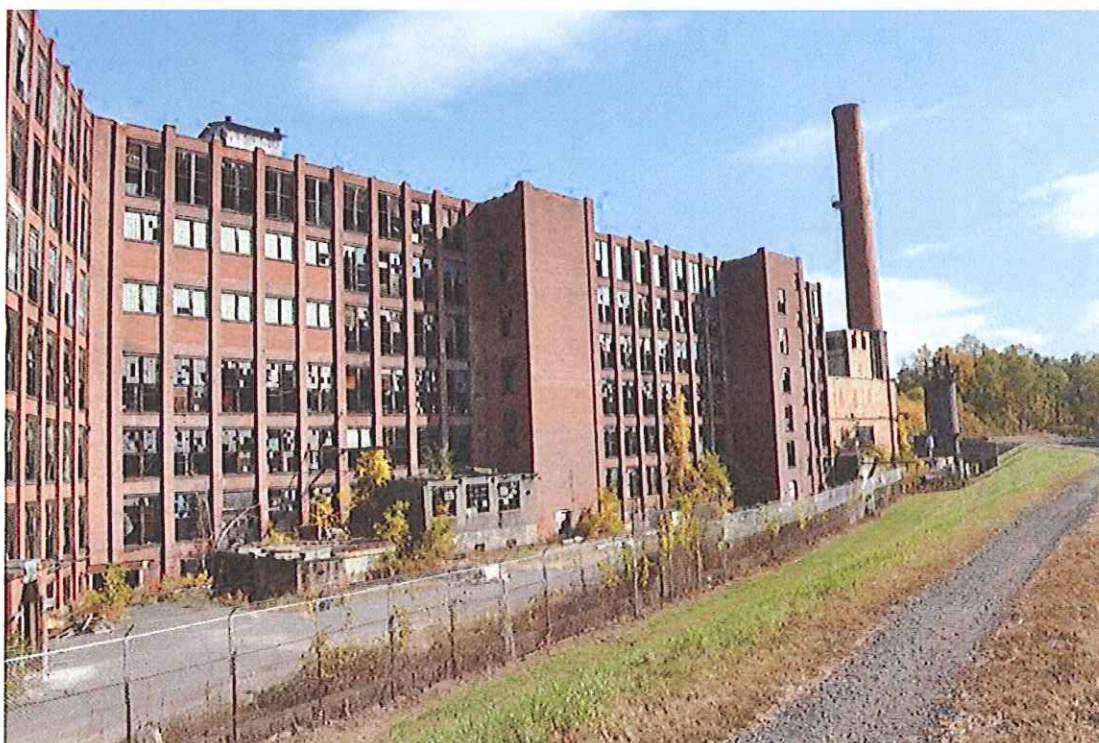
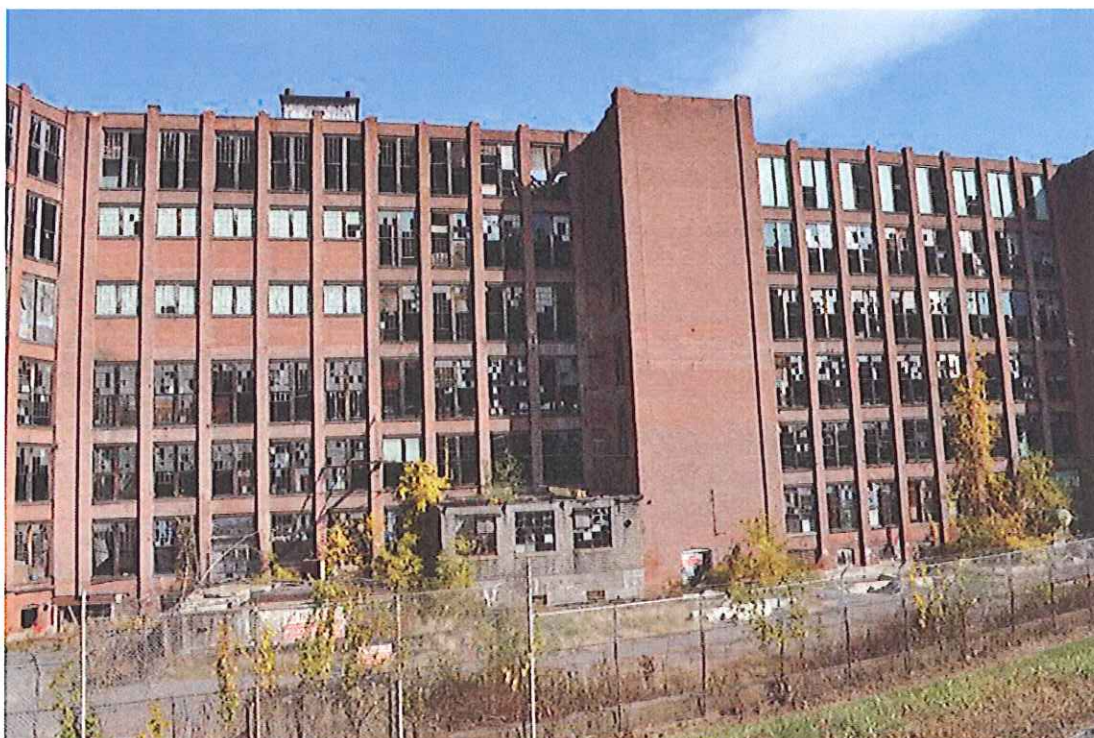
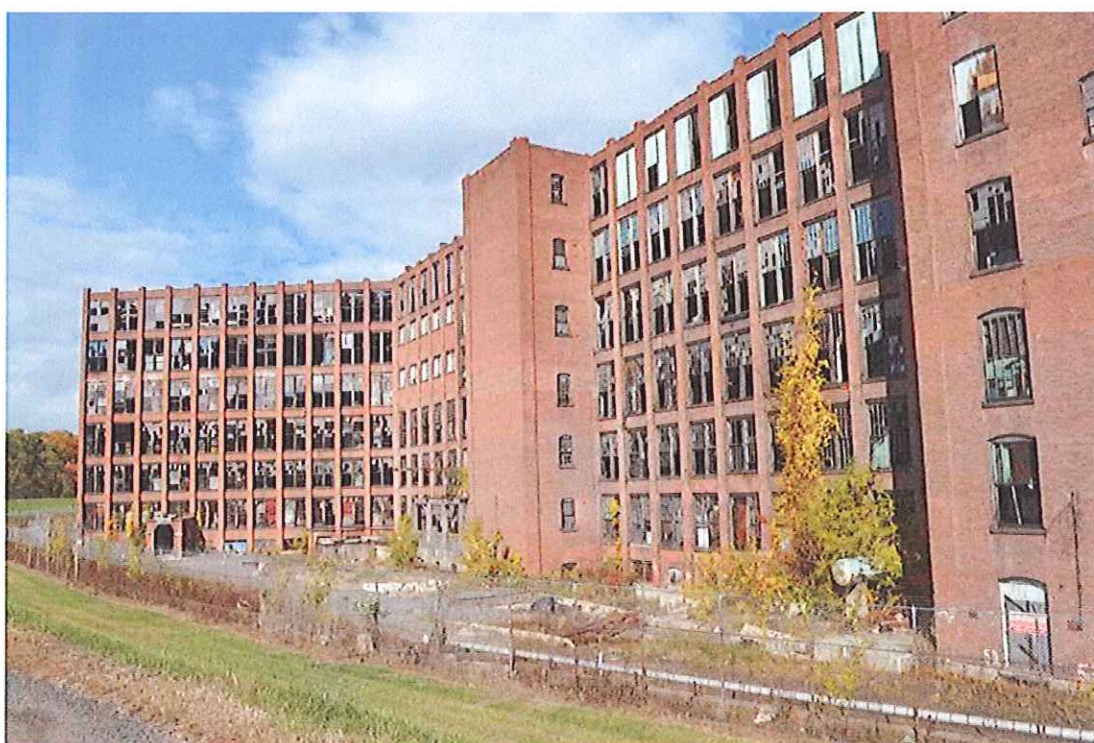
**Building #8** (Photograph #s 4, 5, and 6) is quite similar in appearance and size to Building #7, although it has longer rectangular footprint and prominent projecting brick stair tower sections on the west side.

**4. Building #8, Uniroyal Complex, 154 Grove Street, Chicopee, MA.** View of west elevation, Photographer facing SE, October 2010

**5. Building #8, Uniroyal Complex, 154 Grove Street, Chicopee, MA. View of west elevation, Photographer facing E, October 2010**

**6. Building #8 (with #7 in rear), Uniroyal Complex, 154 Grove Street, Chicopee, MA. View of west elevation Photographer facing NE, October 2010**

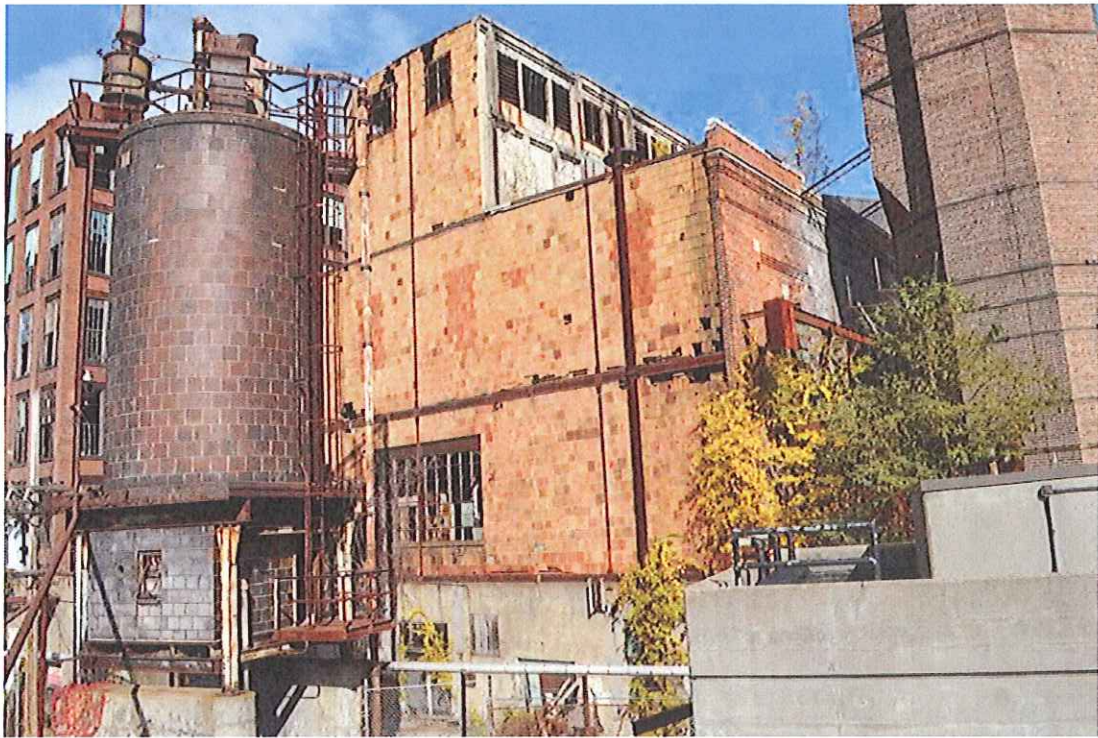
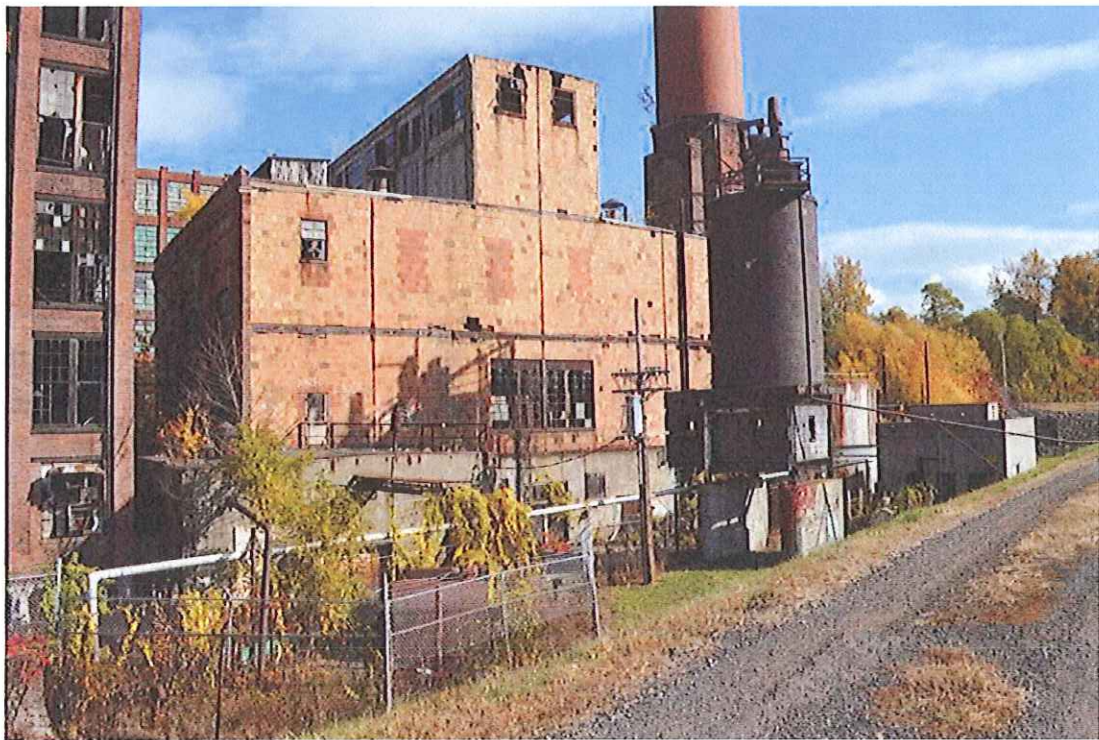
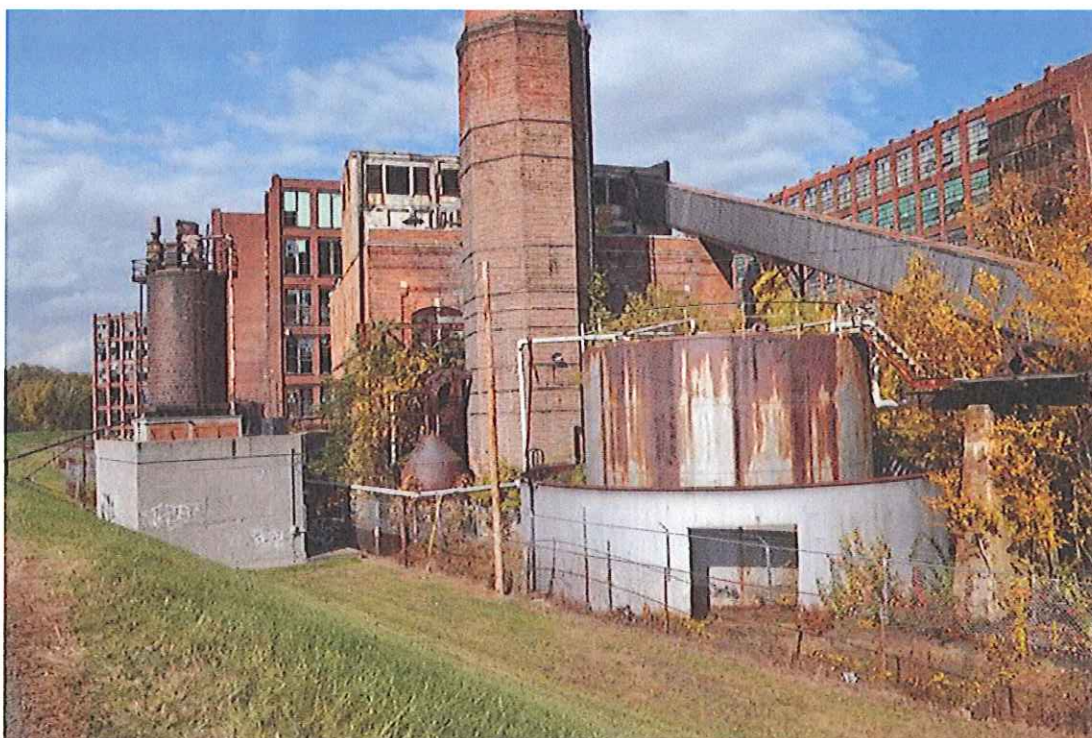
**Building #15** (Photograph # 7, 8 and d 9) is a cube-shaped boiler house structure with a tall central monitor, which is dominated by a brick smokestack to the south. The structure is sheathed in brick on the north and south sides, with terra cotta tile exterior on the west side. A series of metal and tile tanks are adjacent to the boiler house.

**7. Building #15, Uniroyal Complex, 154 Grove Street, Chicopee, MA.** View of west elevation , Photographer facing E, October 2010

**8. Building #15, Uniroyal Complex, 154 Grove Street, Chicopee, MA.** View of west elevation, Photographer facing SE, October 2010

**9. Building #15, Uniroyal Complex, 154 Grove Street, Chicopee, MA.** View of south elevation, Photographer facing NE, October 2010

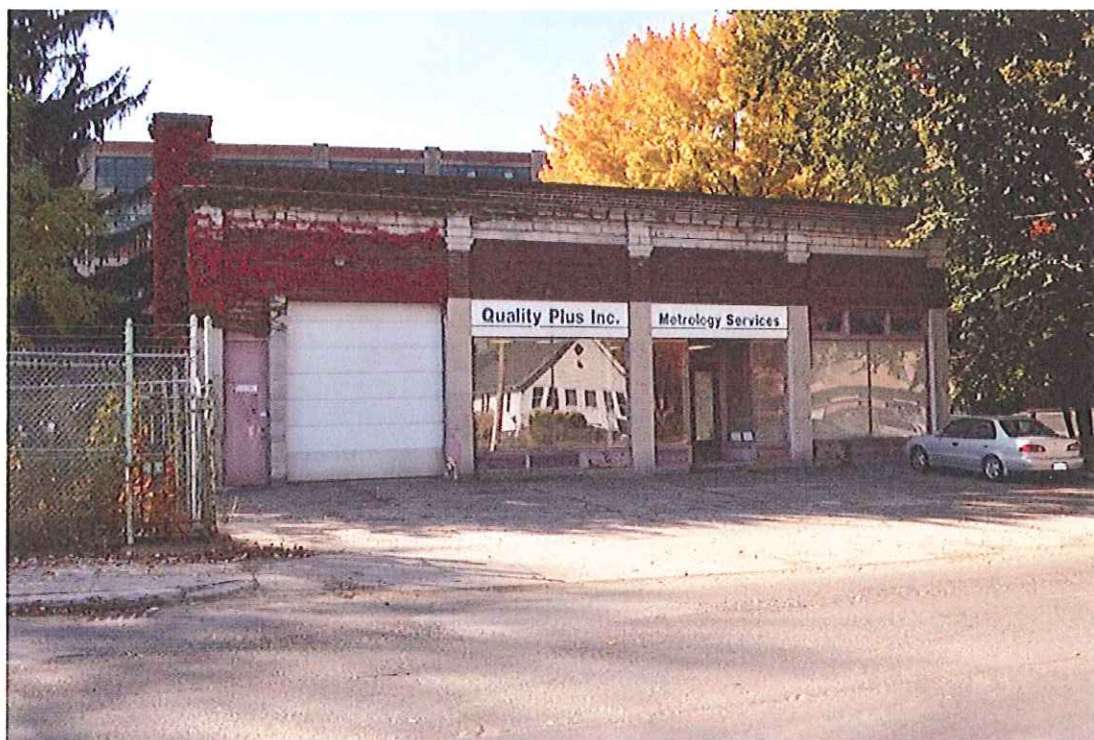
**10. Building #25, Uniroyal Complex, 154 Grove Street, Chicopee, MA.** View of east elevation, Photographer facing W, October 2010

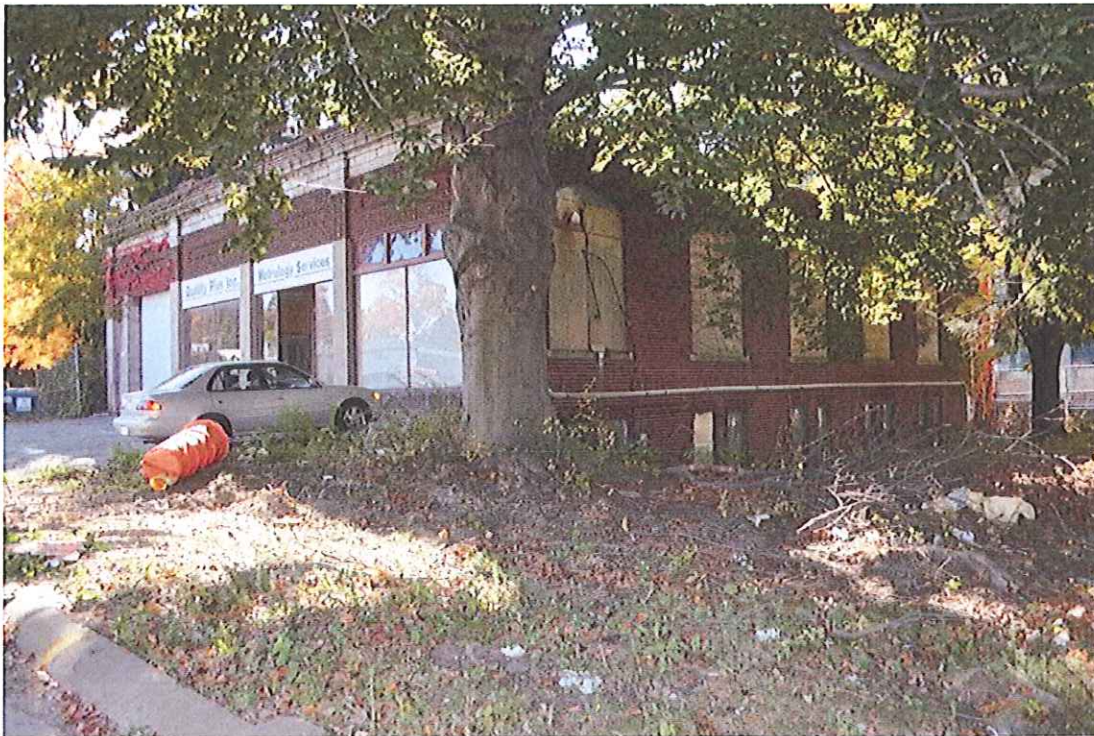
**11. Building #25, Uniroyal Complex, 154 Grove Street, Chicopee, MA. View of front (east) and north elevations, Photographer facing SW, October 2010**

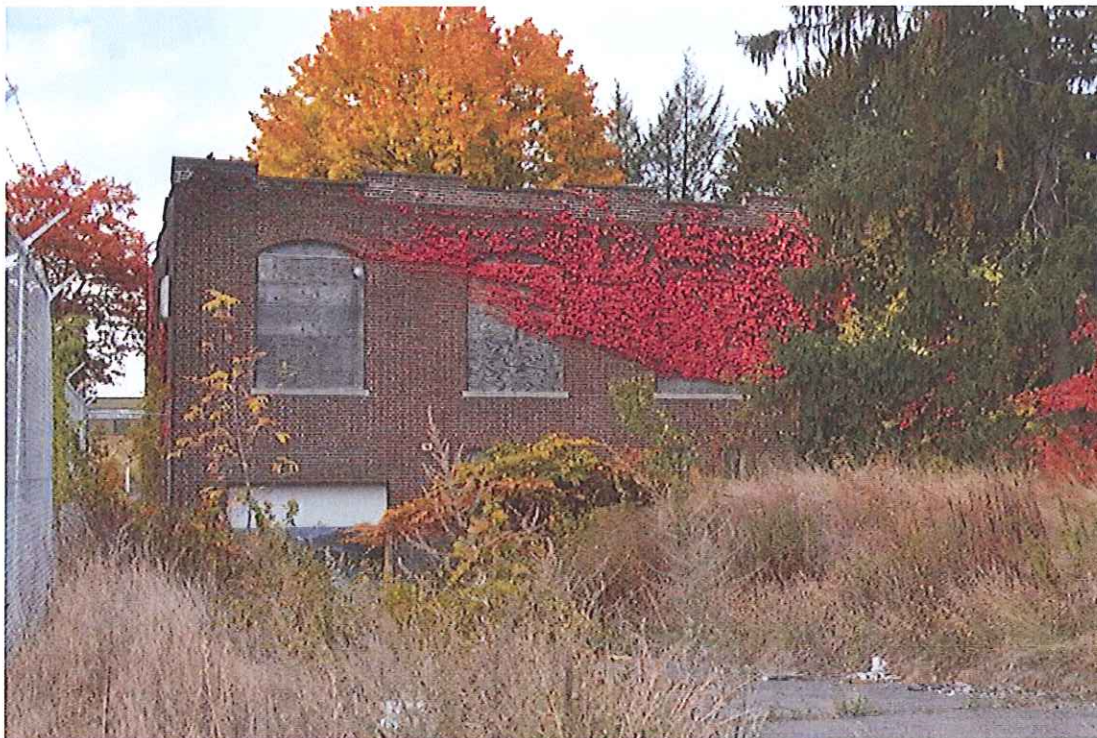
**12. Building #25, Uniroyal Complex, 154 Grove Street, Chicopee, MA. View of south elevation, Photographer facing N, October 2010**

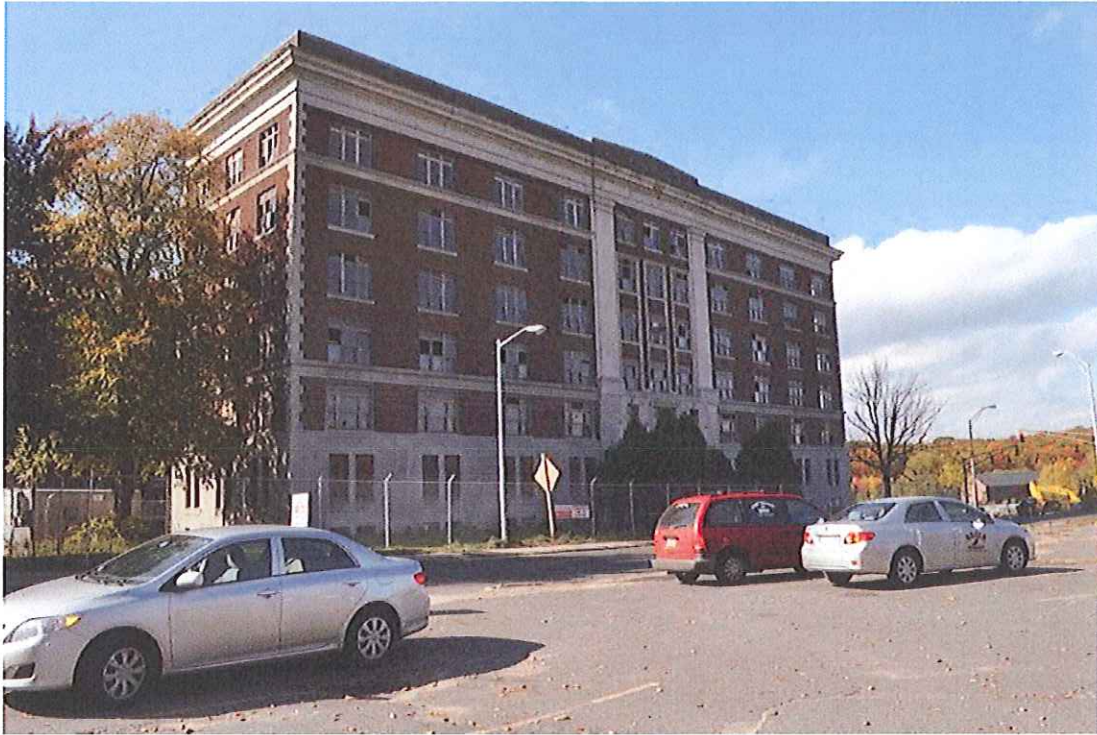
**13. Building #26, Uniroyal Complex, 154 Grove Street, Chicopee, MA. View of front (east) elevation, Photographer facing NW, October 2010**

A Phase 2 structural evaluation of Building #1, Building #3, and the Stair Tower Building section of Building #5 of the Facemate complex and Building #26 of the Uniroyal complex was subsequently prepared by BETA Group, Inc. in August 2010. An addendum to this report was prepared in September 2010, which reassessed these buildings with the newly-issued Eighth Edition of the Commonwealth of Massachusetts' Commercial Building Code. The initial evaluation (see Executive Summary on page 3 of the August 2010 study) found that three of the four buildings (Building #1 and the Stair Tower Building section of Building #5 in the Facemate complex and Building #26 of the Uniroyal complex) were possible candidates for reuse, although costs were relatively high for upgrades on some due to structural/condition issues. These initial evaluations regarding reuse/redevelopment costs were solidified in the addendum report (see page 1 of the September 2010 study), as the costs for rehabilitation of Building #3 (the Clock Tower Building) are now even higher as the result of the updated Massachusetts building code.

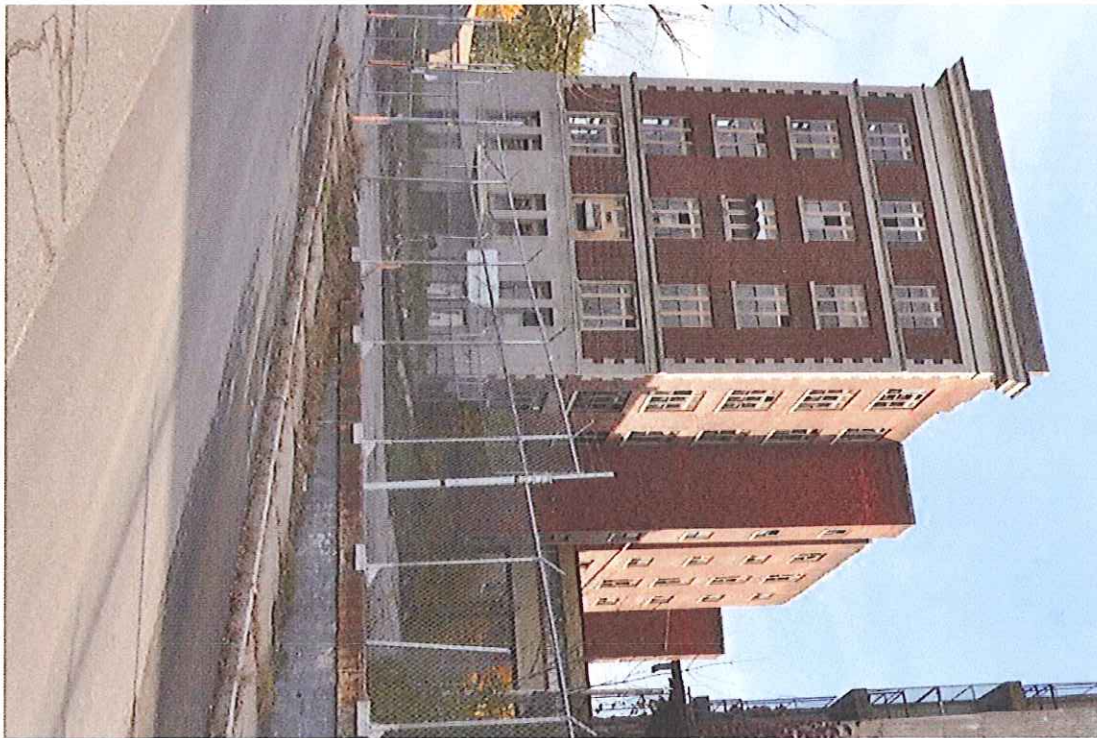
**14. Building #26, Uniroyal Complex, 154 Grove Street, Chicopee, MA. View of north elevation, Photographer facing S, October 2010**

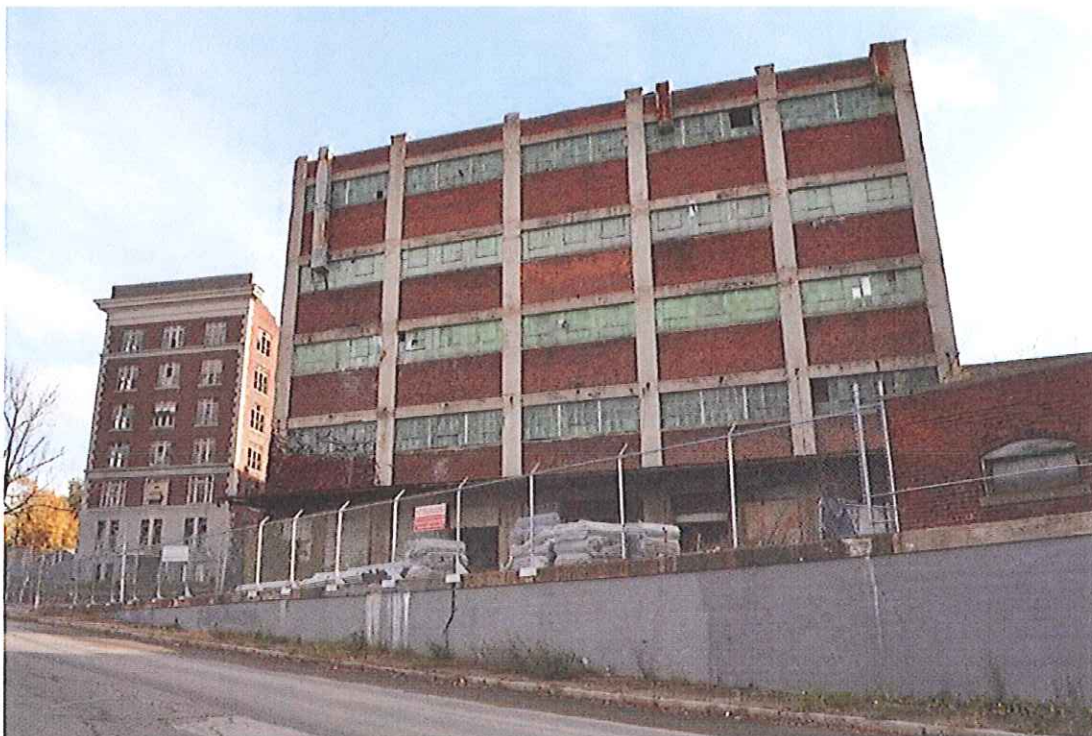
**15. Building #26 (on left) and Building #27, Uniroyal Complex, 154 Grove Street, Chicopee, MA. View of north elevations, Photographer facing S, October 2010**

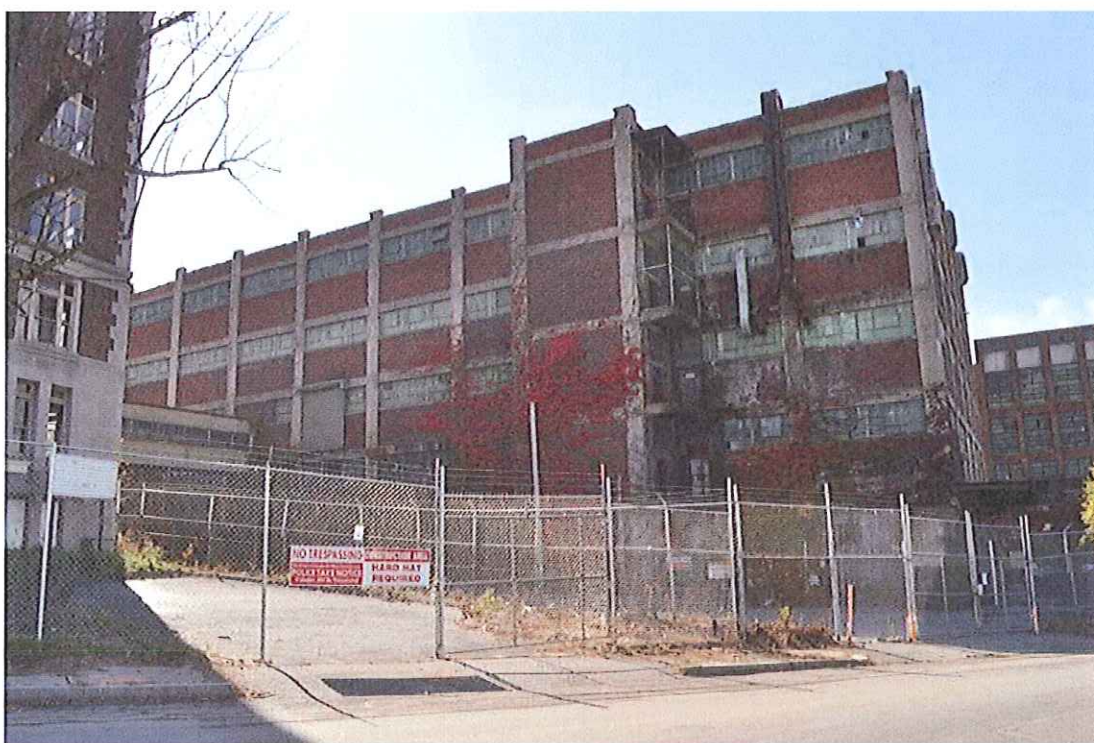
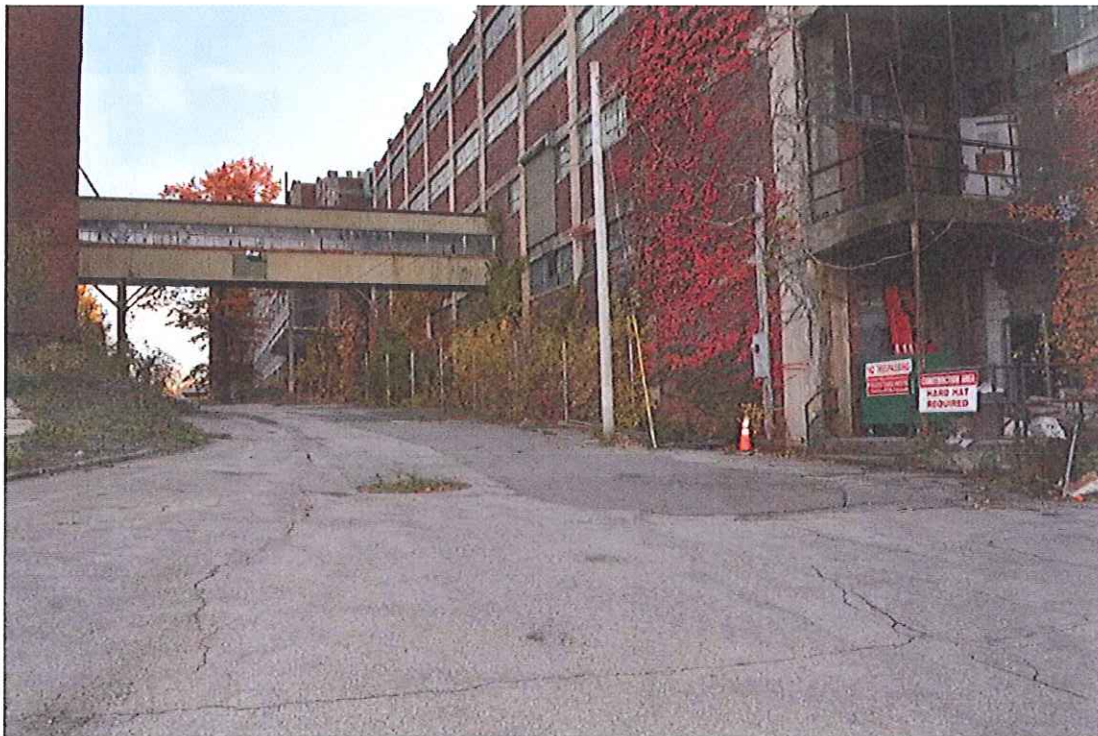
**Building #27** (Photograph #15, 16 and 17) is a 5-story concrete pier and brick spandrel rectangular industrial building with a flat roof. The multi-pane window sash seen throughout the building is presumably metal.

**16. Building #27, Uniroyal Complex, 154 Grove Street, Chicopee, MA. View of east elevation, Photographer facing W, October 2010**

**17. Building #27 with #42 in rear, Uniroyal Complex, 154 Grove Street, Chicopee, MA.**  
View of east elevations, Photographer facing SW, October 2010

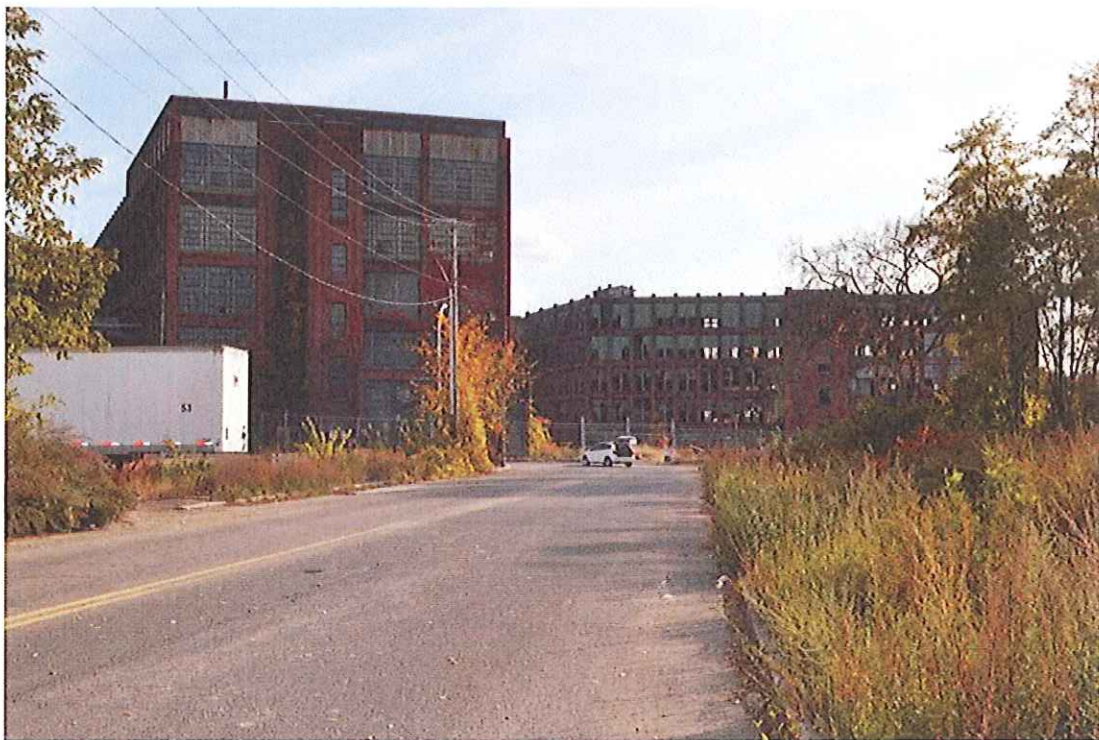
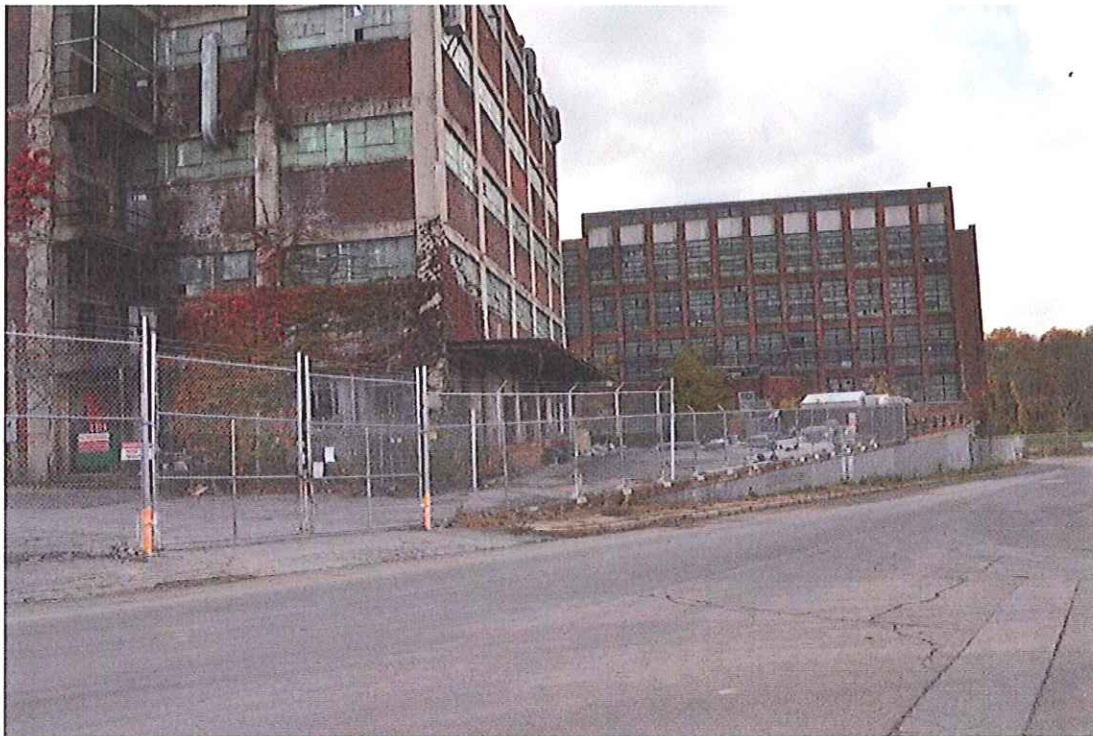
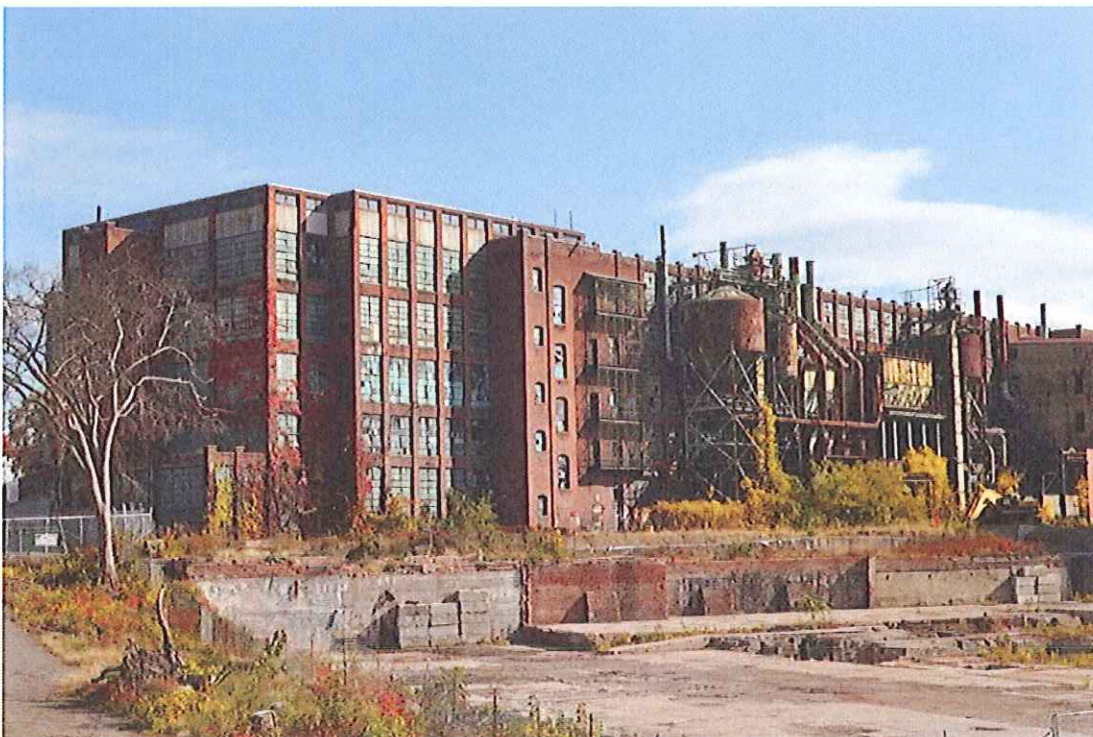
**Building #28** (Photograph #18, 19 and 20) is another 6-story brick pier and spandrel rectangular building, similar to Building #7 and #8, although it features single large multi-pane sash in the bays and has projecting brick stair towers on the north and west elevations.

**18. Building #28 on left and #7 on right, Uniroyal Complex, 154 Grove Street, Chicopee, MA.** View of north elevations, Photographer facing S, October 2010

**19. Building #28 (with #27 at left) Uniroyal Complex, 154 Grove Street, Chicopee, MA.** View of east elevation , Photographer facing W, October 2010

**20. Building #28, Uniroyal Complex, 154 Grove Street, Chicopee, MA.** View of north and west elevations, Photographer facing SE, October 2010

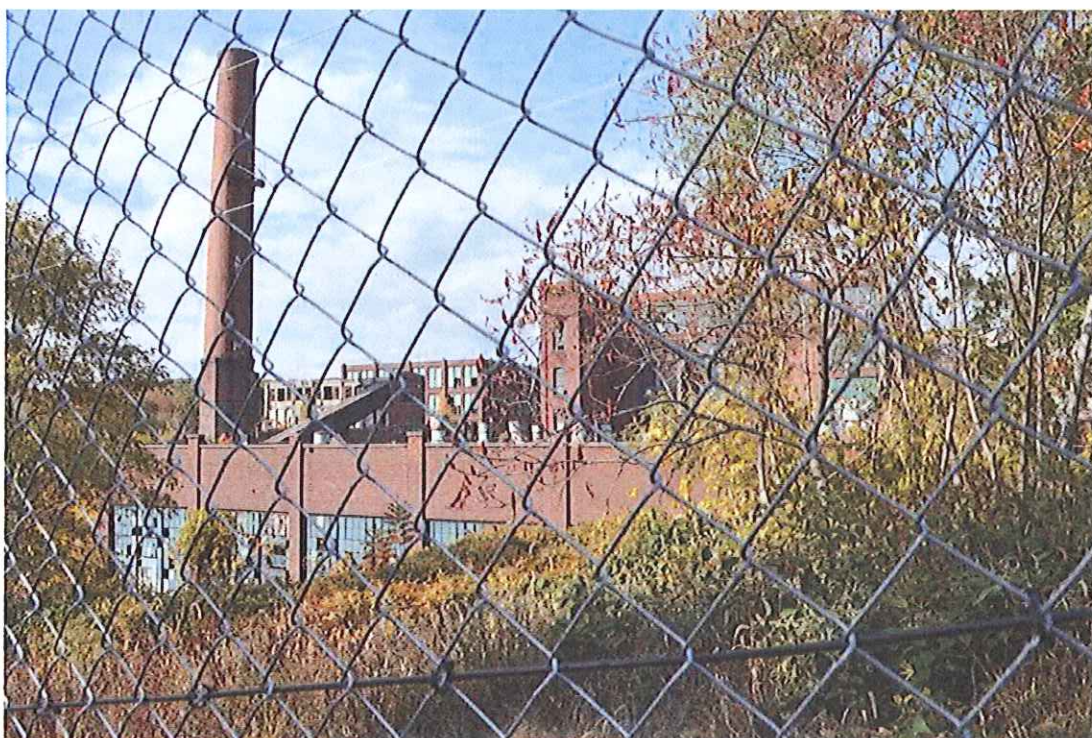
**Building #33** (Photograph #21) is a square plan 2-story brick building connected to the south end of Building #28. The flat-roofed structure displays the same brick pier and spandrel construction and multiple pane sash windows of nearby buildings within the complex.

**21. Building #33 (in foreground) with smokestack of #15 and portion of #28 in rear , Uniroyal Complex, 154 Grove Street, Chicopee, MA. View of south elevations, Photographer facing NW, October 2010**
